Debris/Ice/TPS Assessment and Integrated Photographic Analysis of Shuttle Mission STS-91

**DEBRIS/ICE/TPS ASSESSMENT
AND
INTEGRATED PHOTOGRAPHIC ANALYSIS
OF
SHUTTLE MISSION STS-91**

2 June 1998

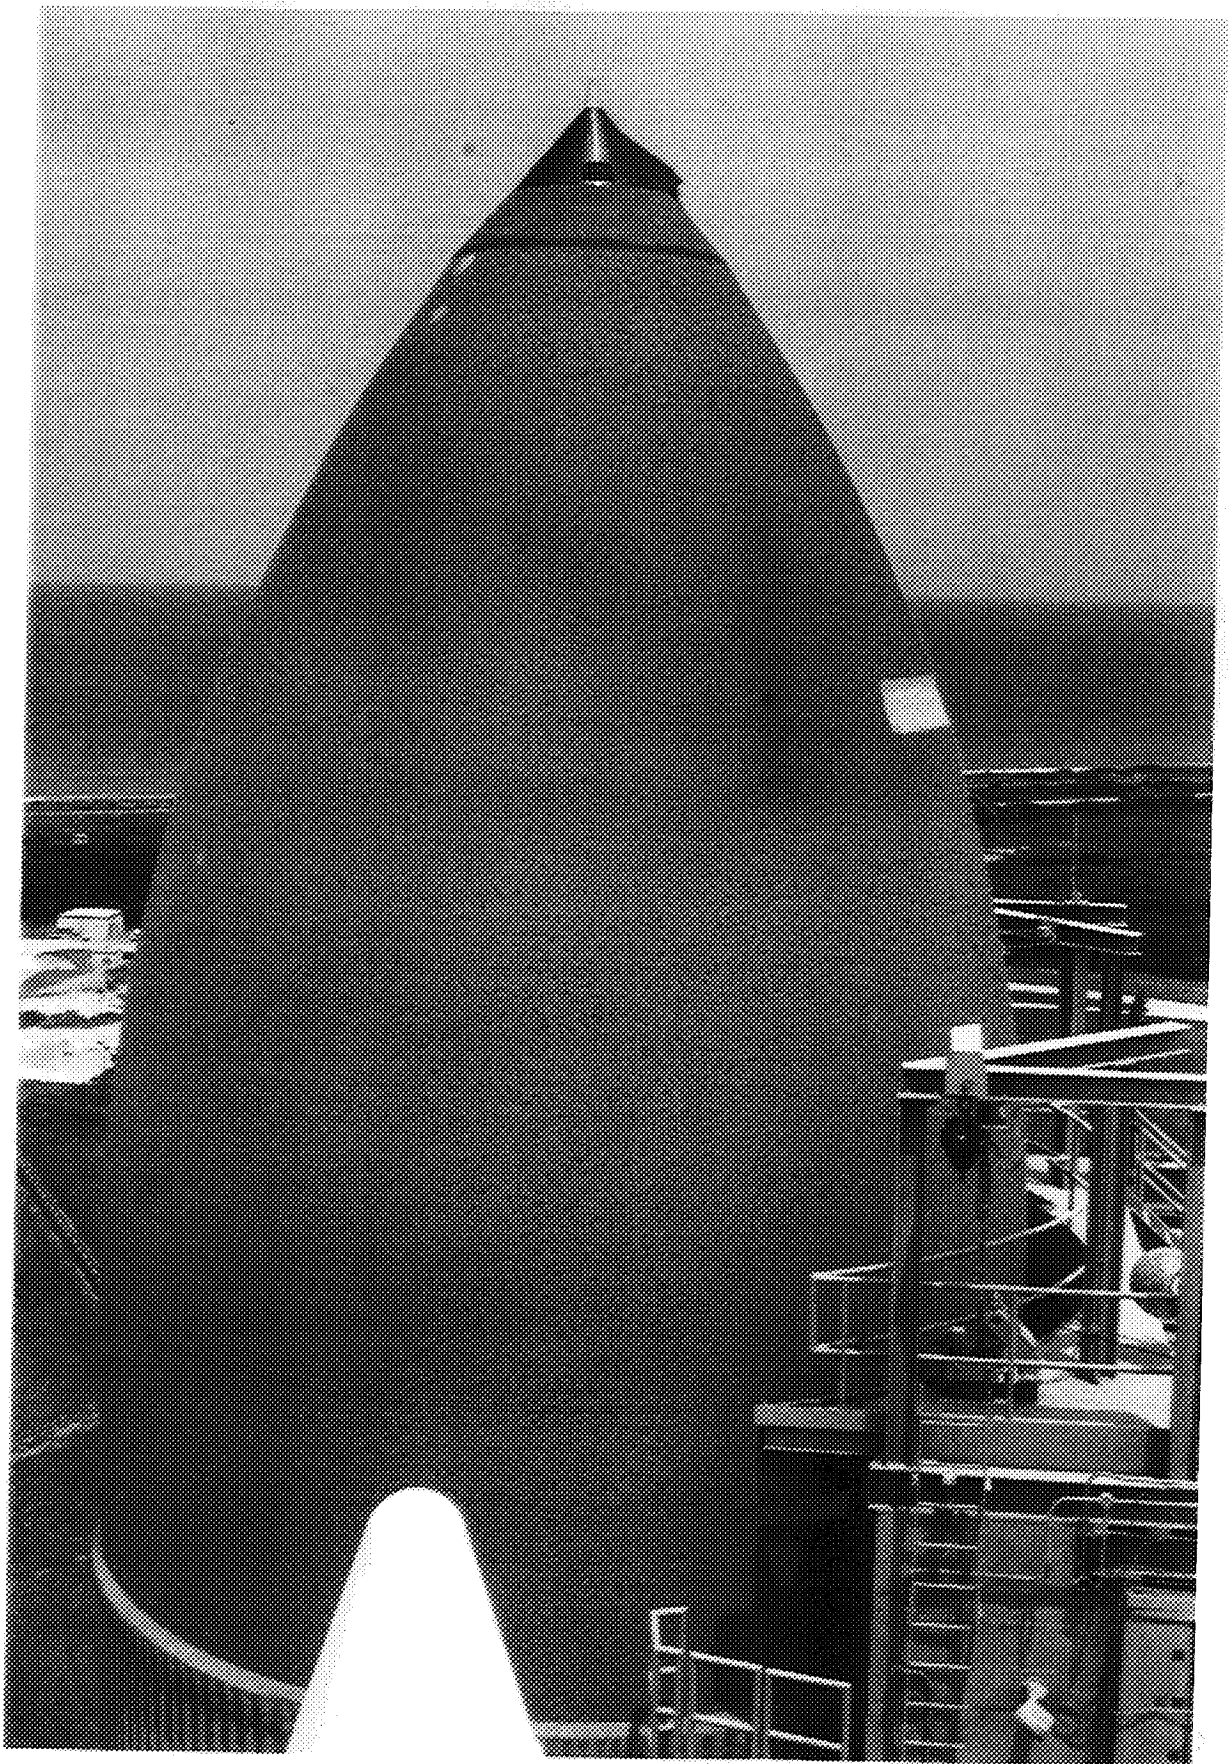
Photo 2: ET-96 SLWT LO2 Tank

A major vehicle configuration change, and the reason for the tanking test, was the first use of the new Super Light Weight (External) Tank (SLWT). Note black composite nose cone, visible welds along panel lines due to the thinner foam, and the sanded area on the +Z side.

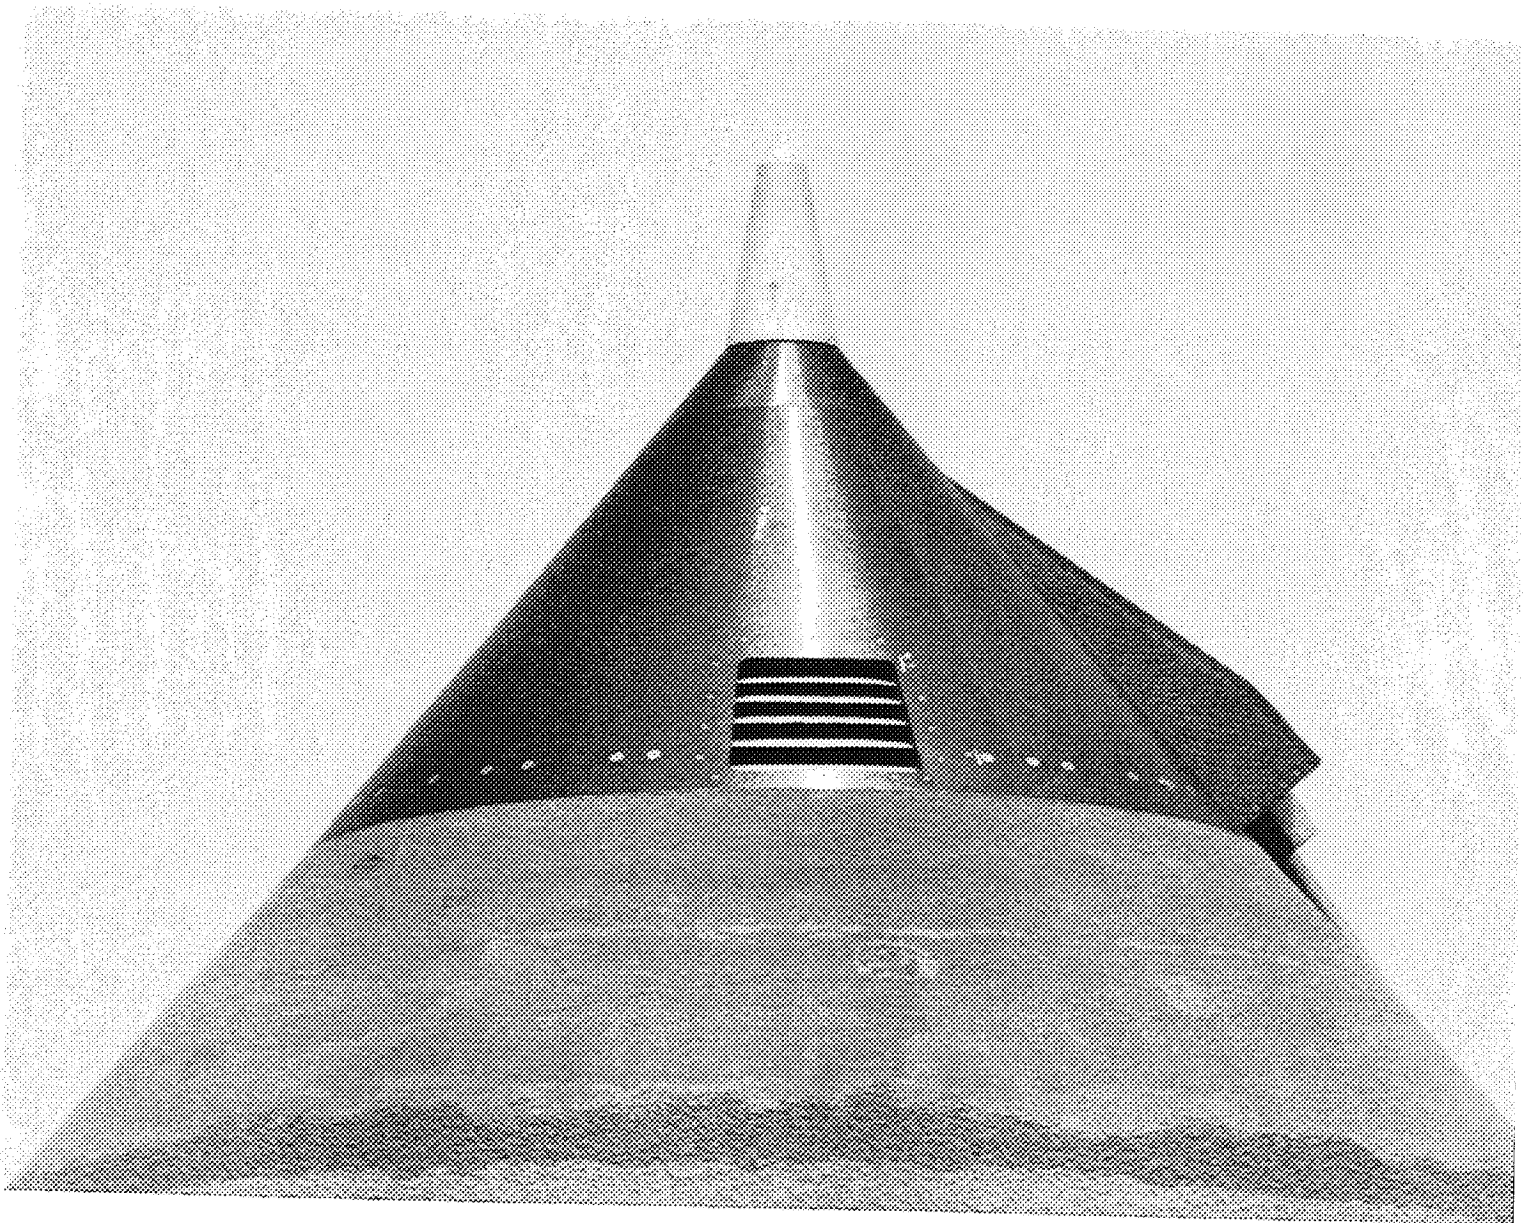
Photo 3: Composite Nose Cone

This is the second use/flight of the graphite-epoxy composite nose cone

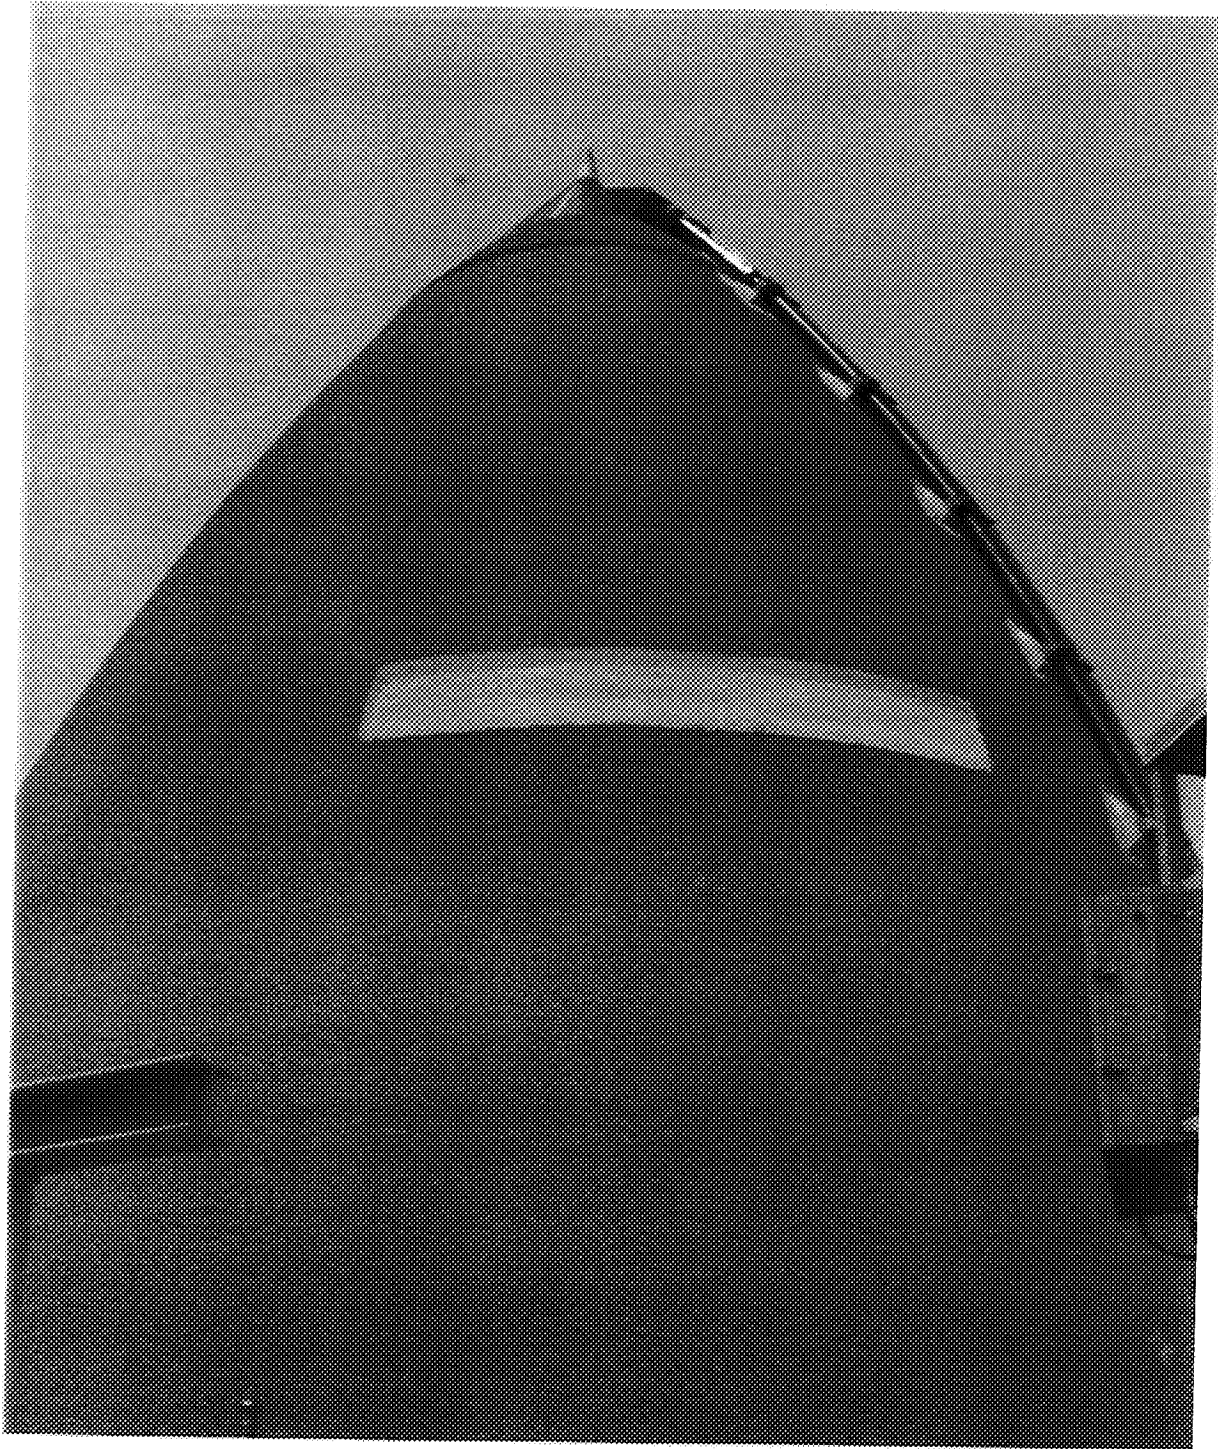
Photo 4: +Z Side Sanded Area

Postulated contour deviations on the LO2 tank forward-to-aft ogive weld (station 536, +Z side) could have resulted in as-sprayed NCFI TPS cracking after the tank was pressurized. Per FEC, a local area 100 inches long by 11 inches wide was sanded over the suspect area to reduce the TPS outer fiber strain and increase the strain capability of the foam. The foam thickness was reduced from an average of 2.30 inches to 1.25 inches. After machining, the edges of the trim area were beveled.

The sanded area on the LO2 tank ogive exhibited no anomalies and averaged 4 degrees Fahrenheit less (as measured by the infrared radiometer) than the adjacent acreage foam. No ice, frost, or condensate accumulations were detected.

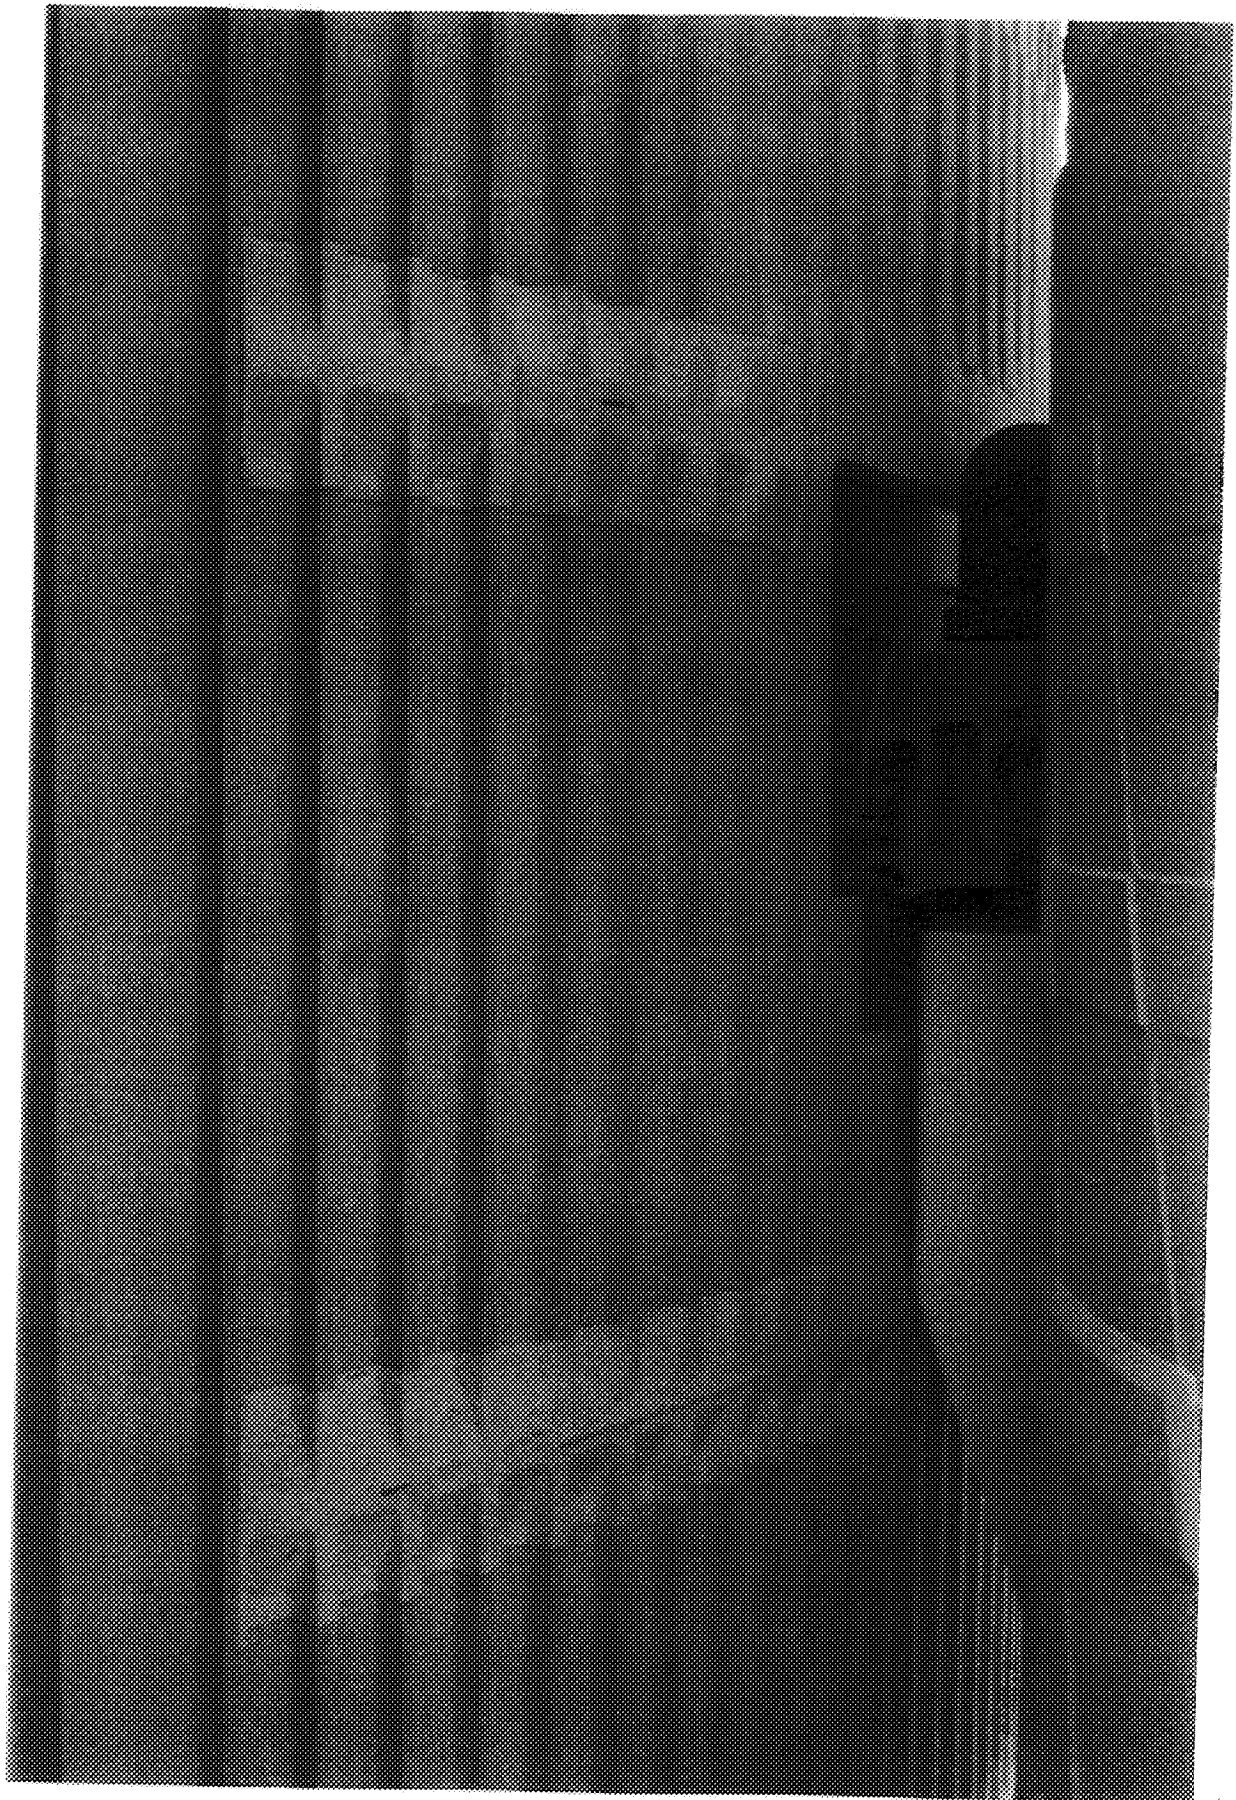
Photo 5: SLWT Intertank Stringers

Intertank and thrust panel stringer heads/valleys are machined in the SLWT configuration

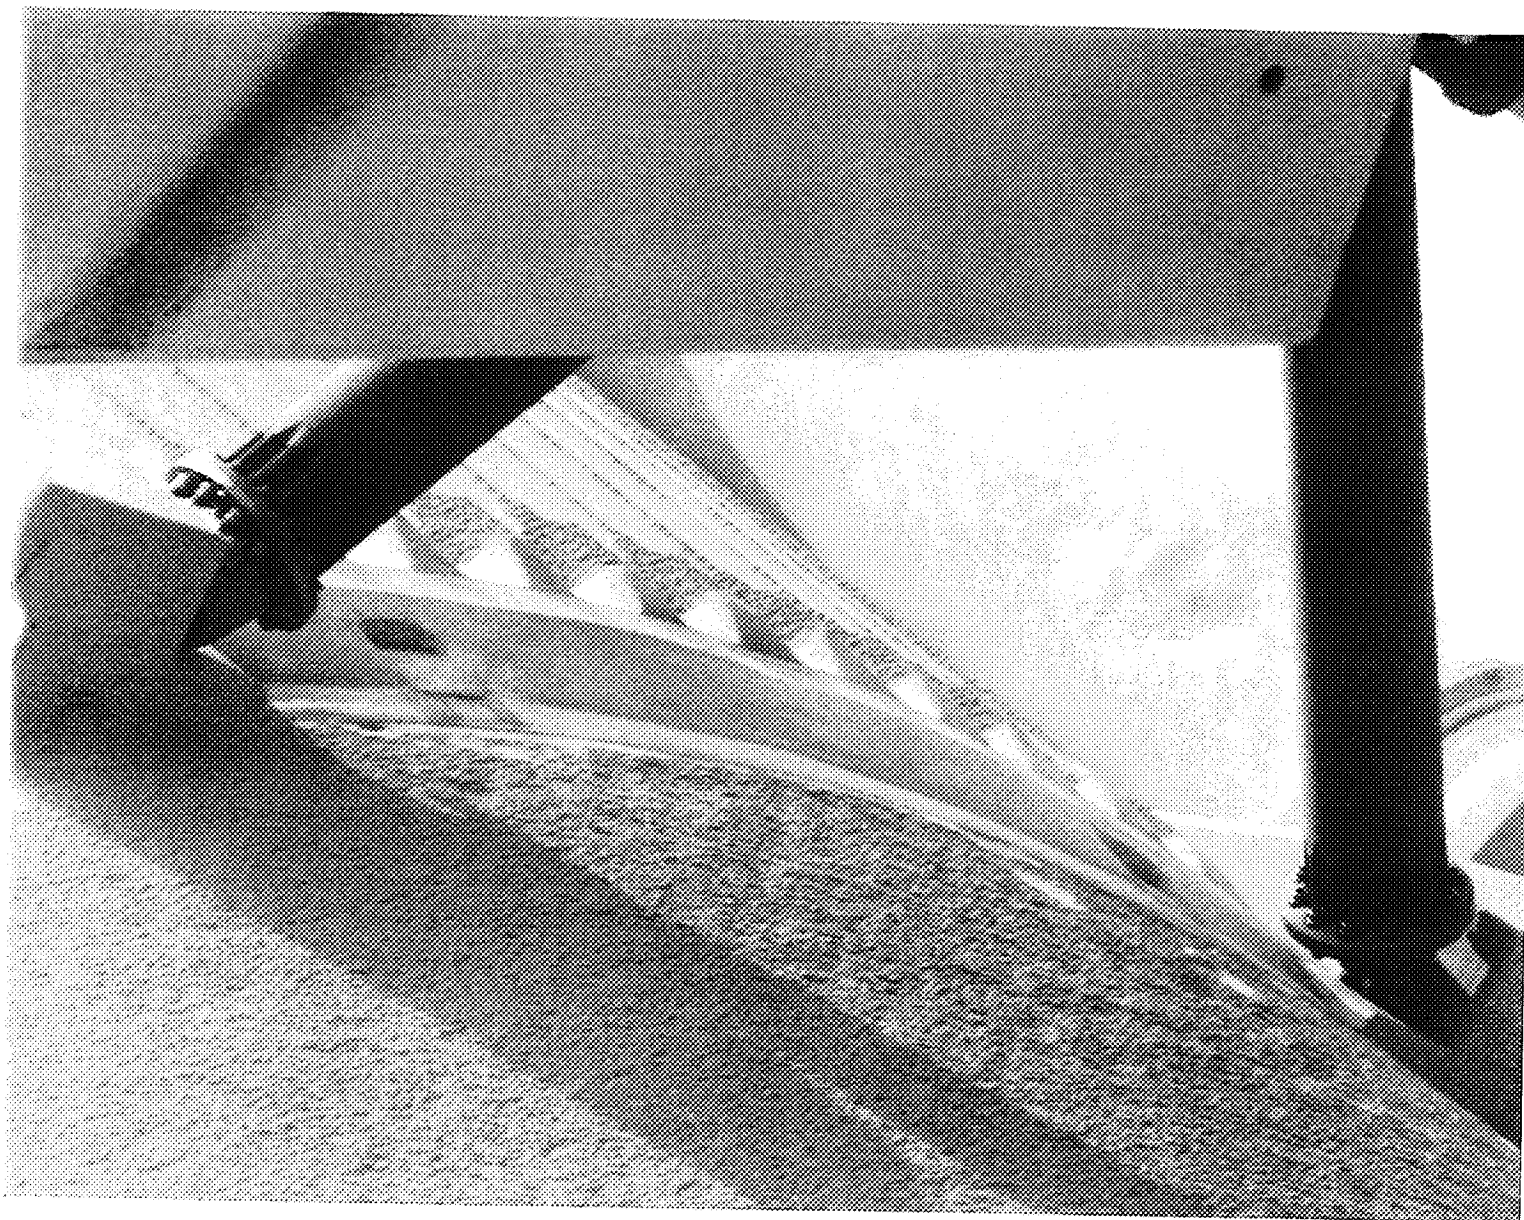
Photo 12: Bipods

No anomalies were detected on the bipod stand-off jack pad closeouts
or the spindle housing closeouts

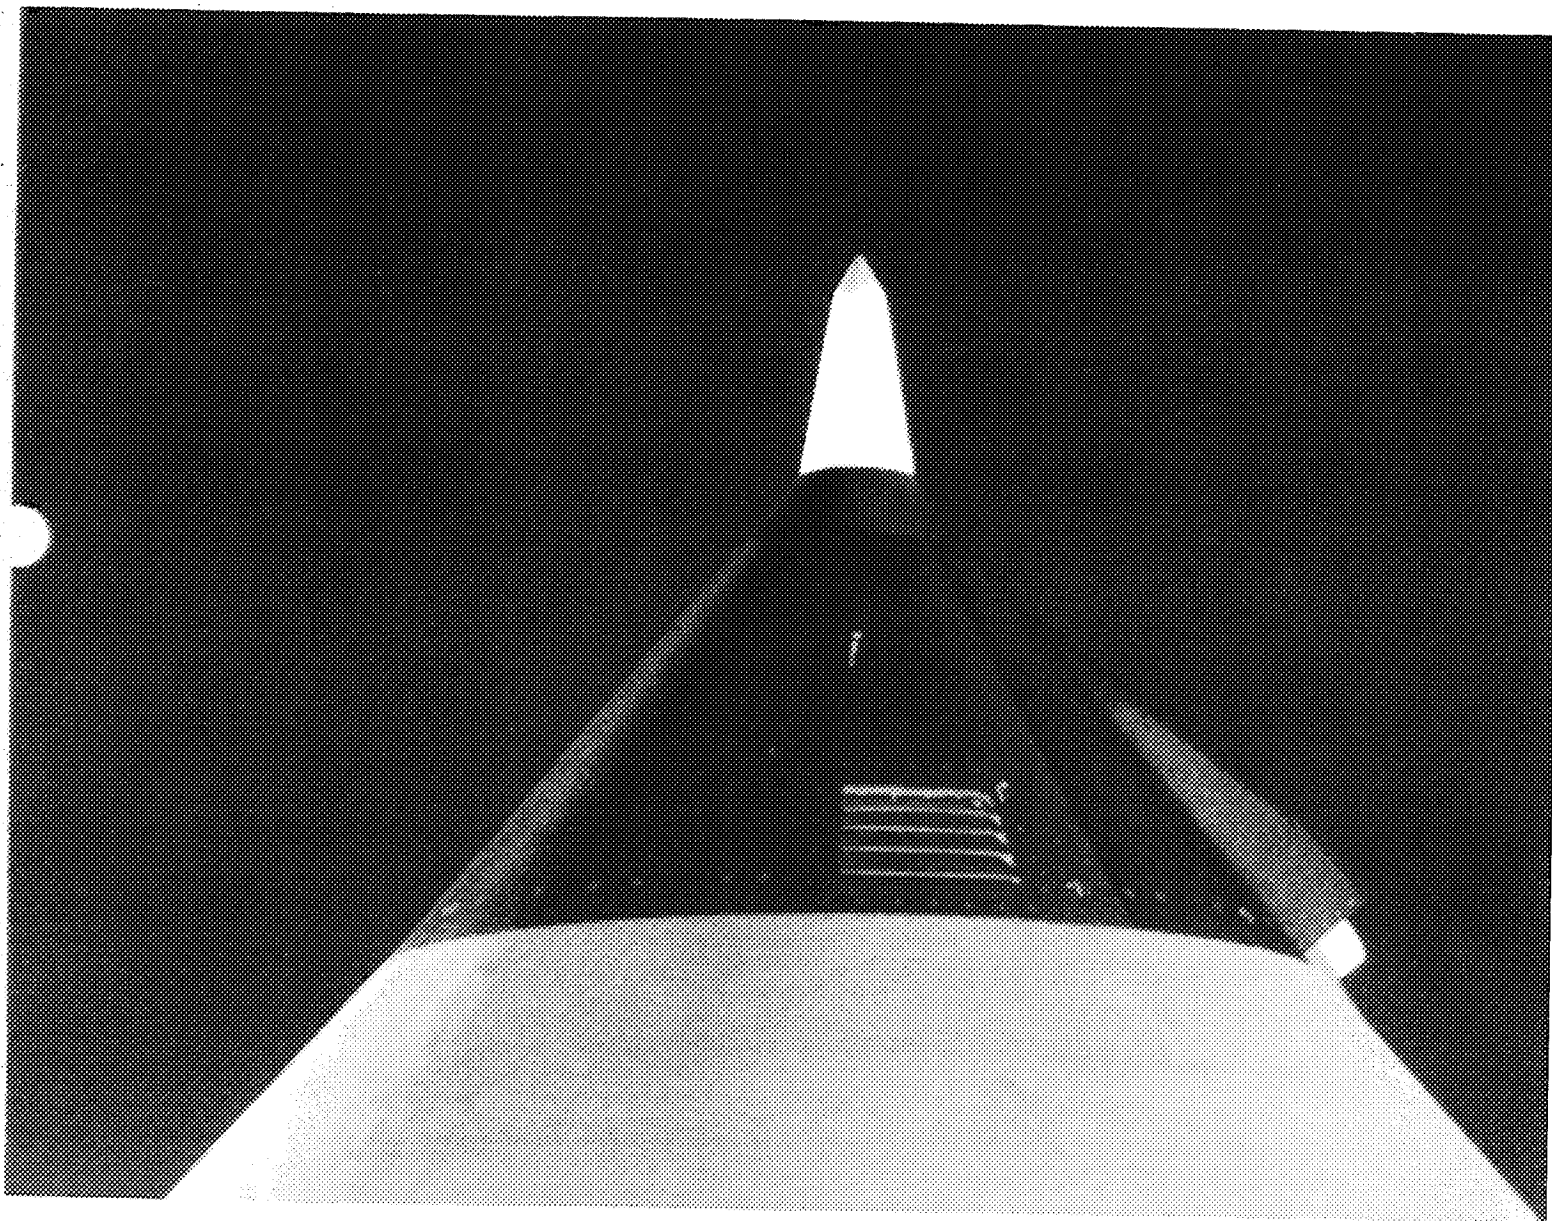
Photo 16: Composite Nose Cone

No anomalies were detected on the black graphite-epoxy composite nose cone

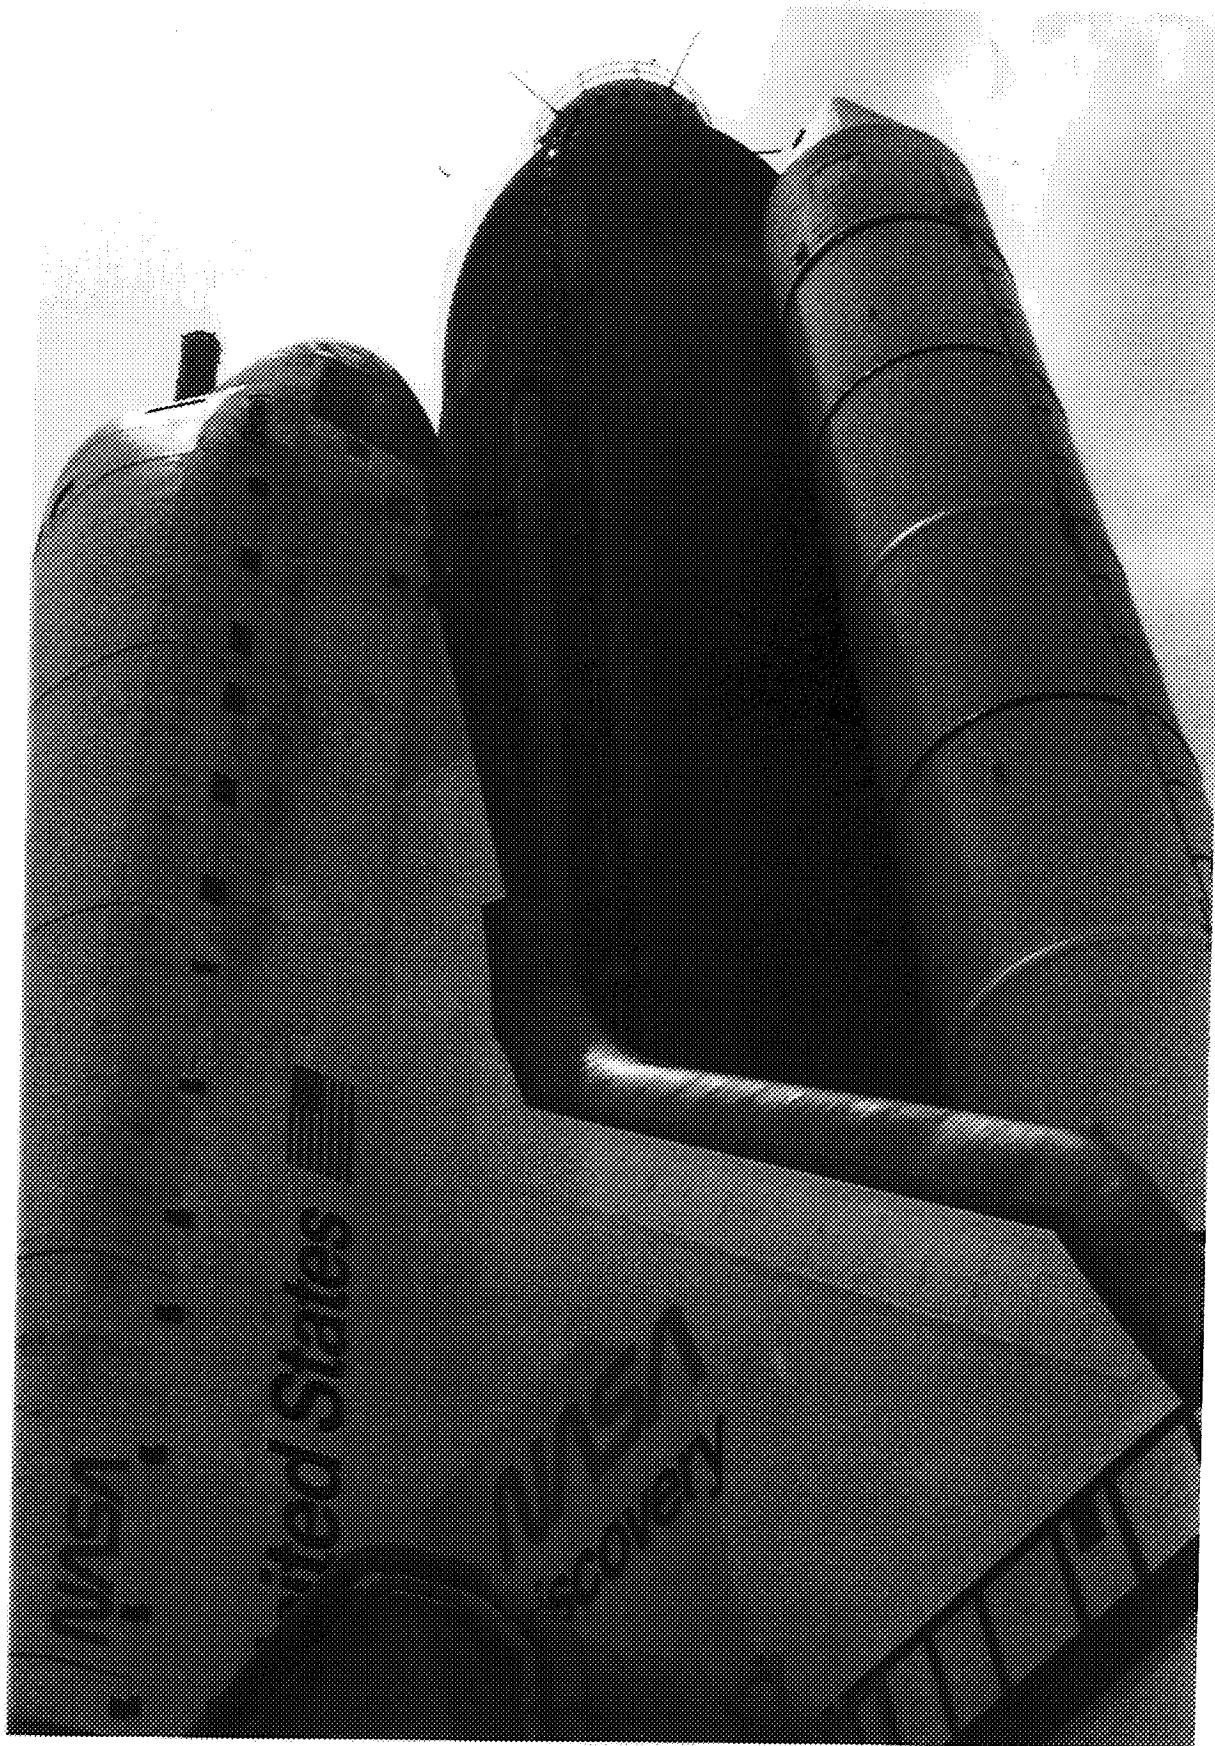
Photo 20: STS-91 Ready for Launch

OV-103 Discovery, ET-96 first Super Light Weight Tank, and BI-091 SRB's. The Final Inspection Team observed very light condensate, but no ice or frost accumulations, on the LH2 tank acreage. TPS surface temperatures ranged from 76 to 82 degrees F.

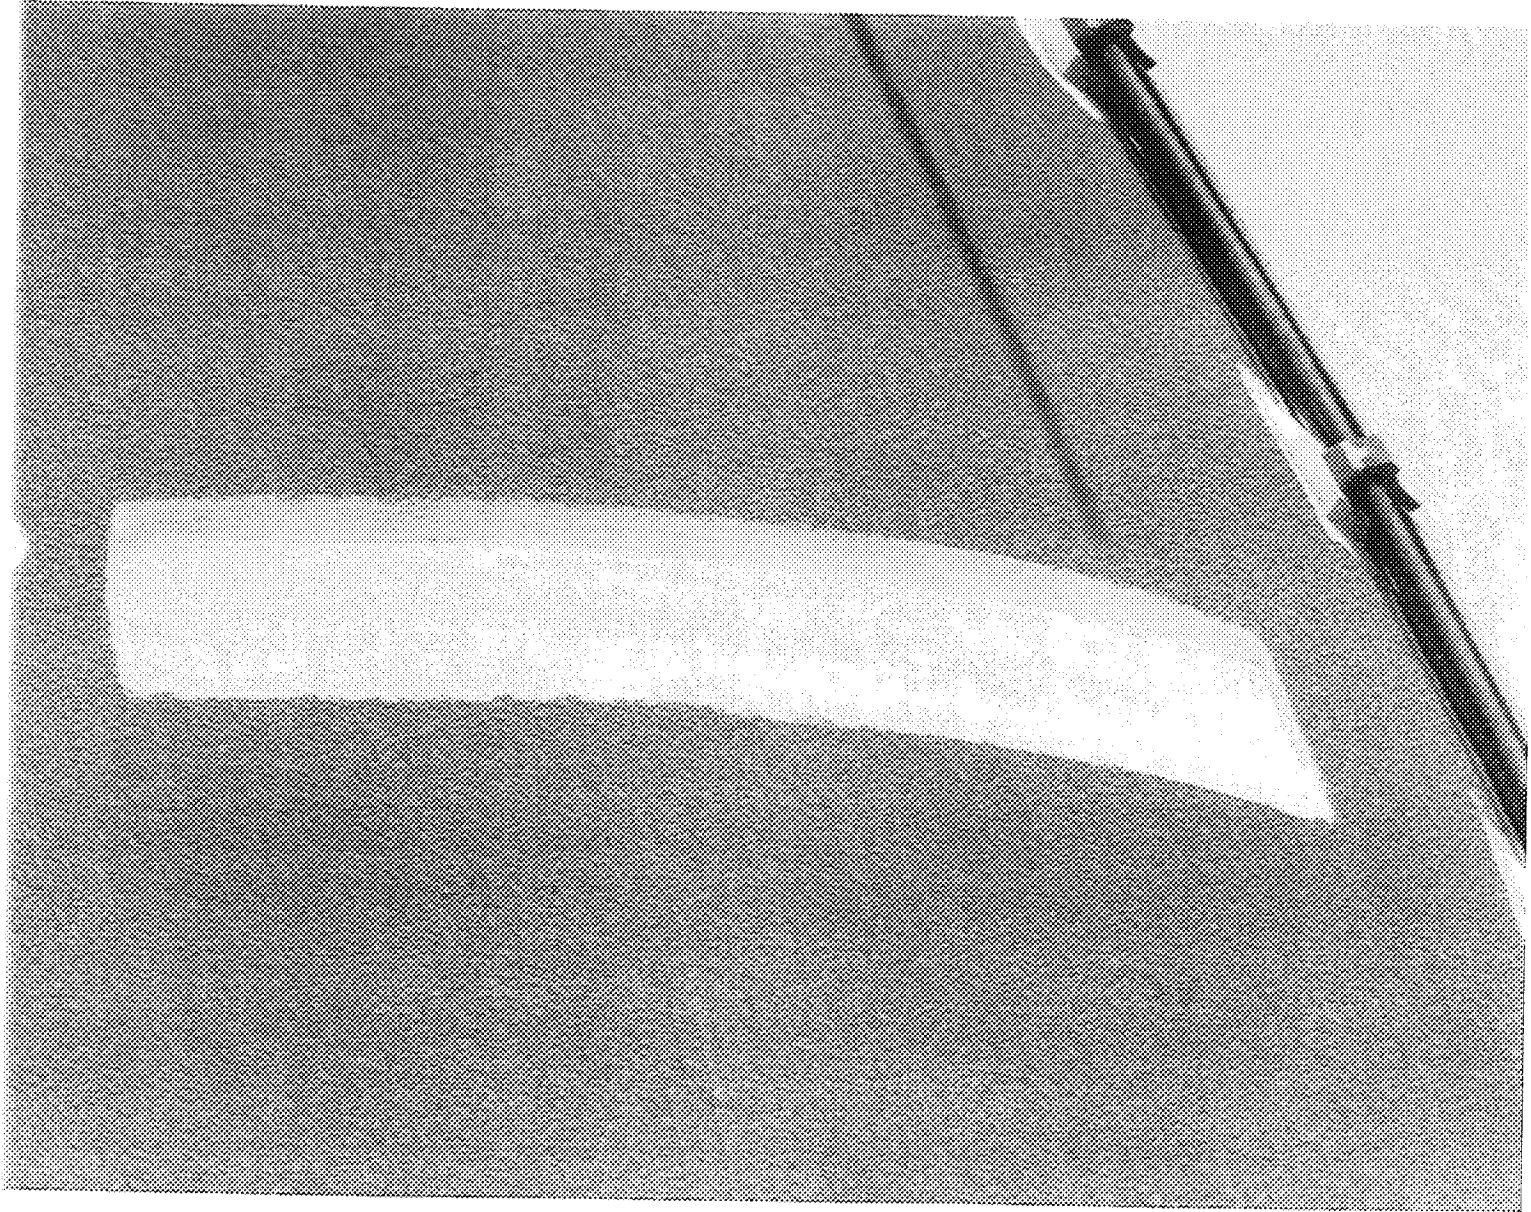
Photo 23: LO2 Tank Sanded Area

The sanded area on the LO2 tank ogive exhibited no anomalies

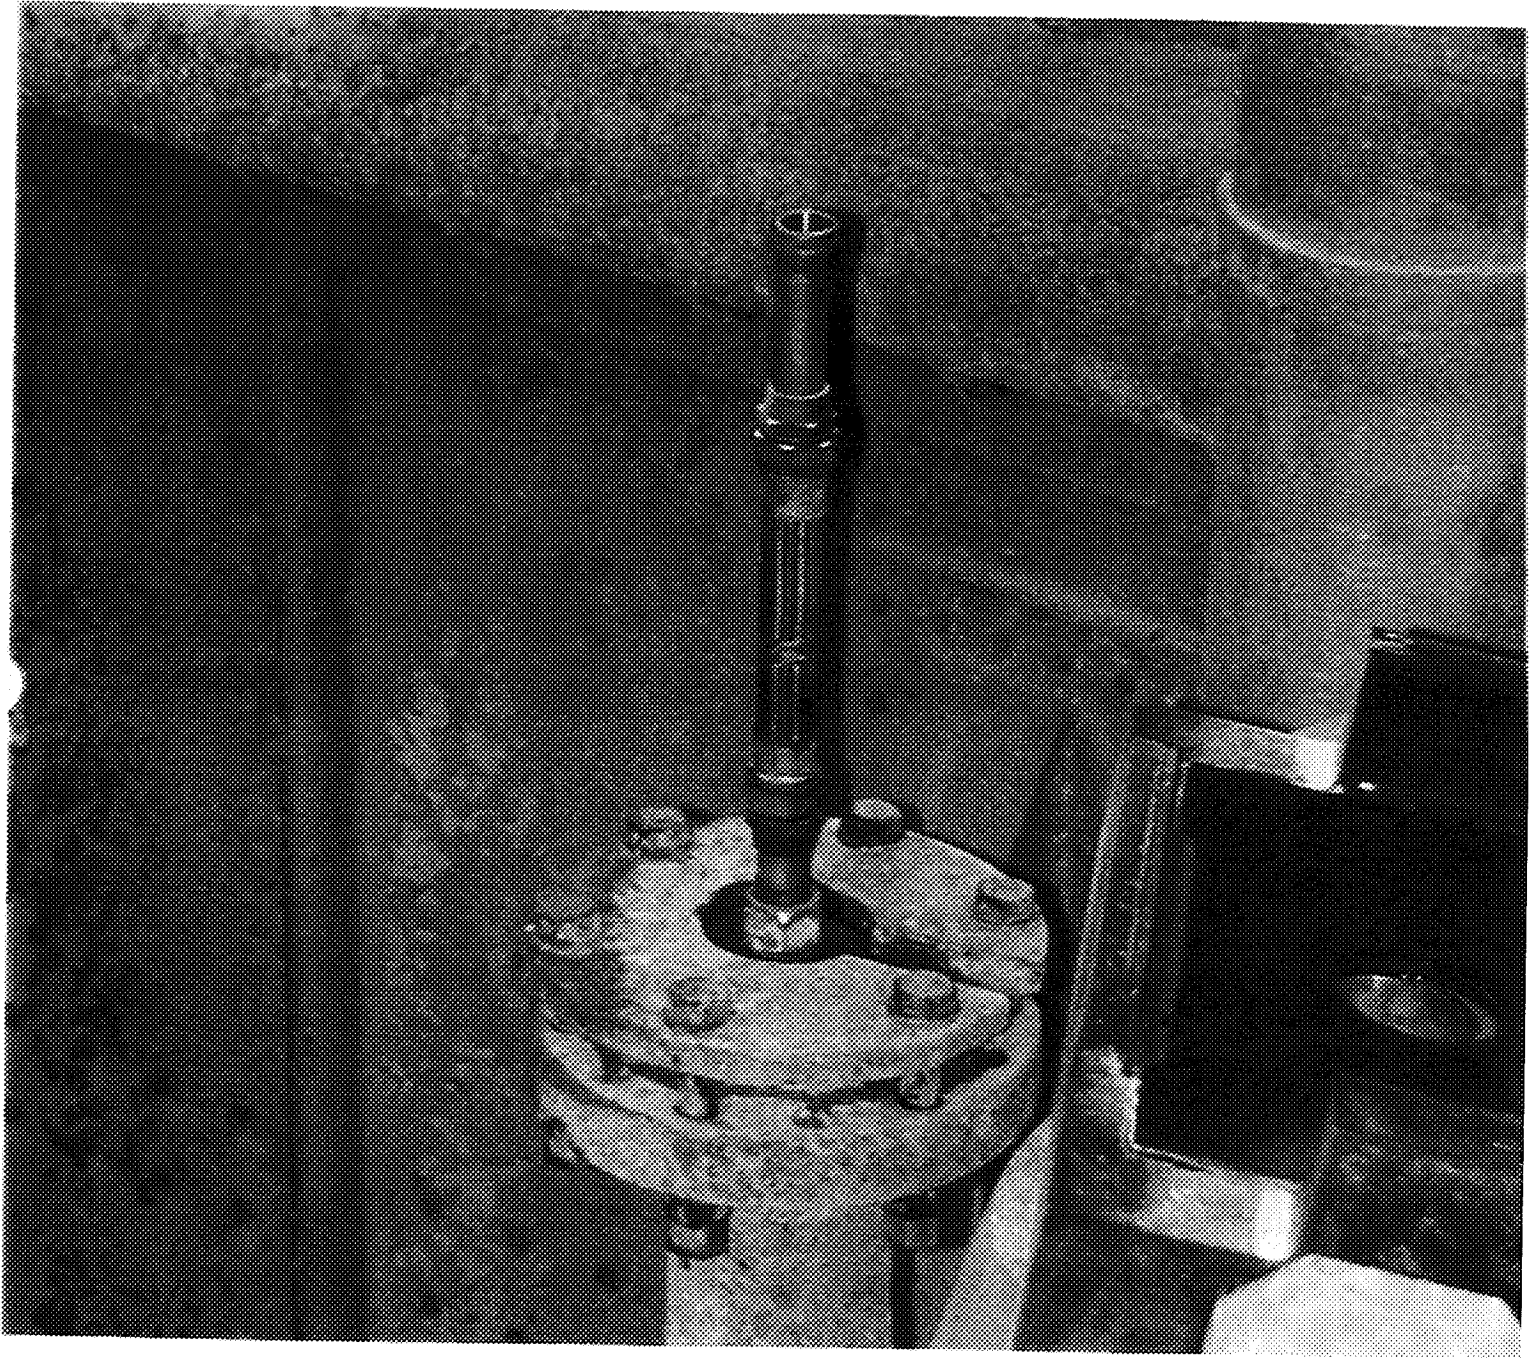
Photo 29: Right SRB Aft Skirt GN2 Purge Line

The right SRB aft skirt GN2 purge line was intact and upright after liftoff

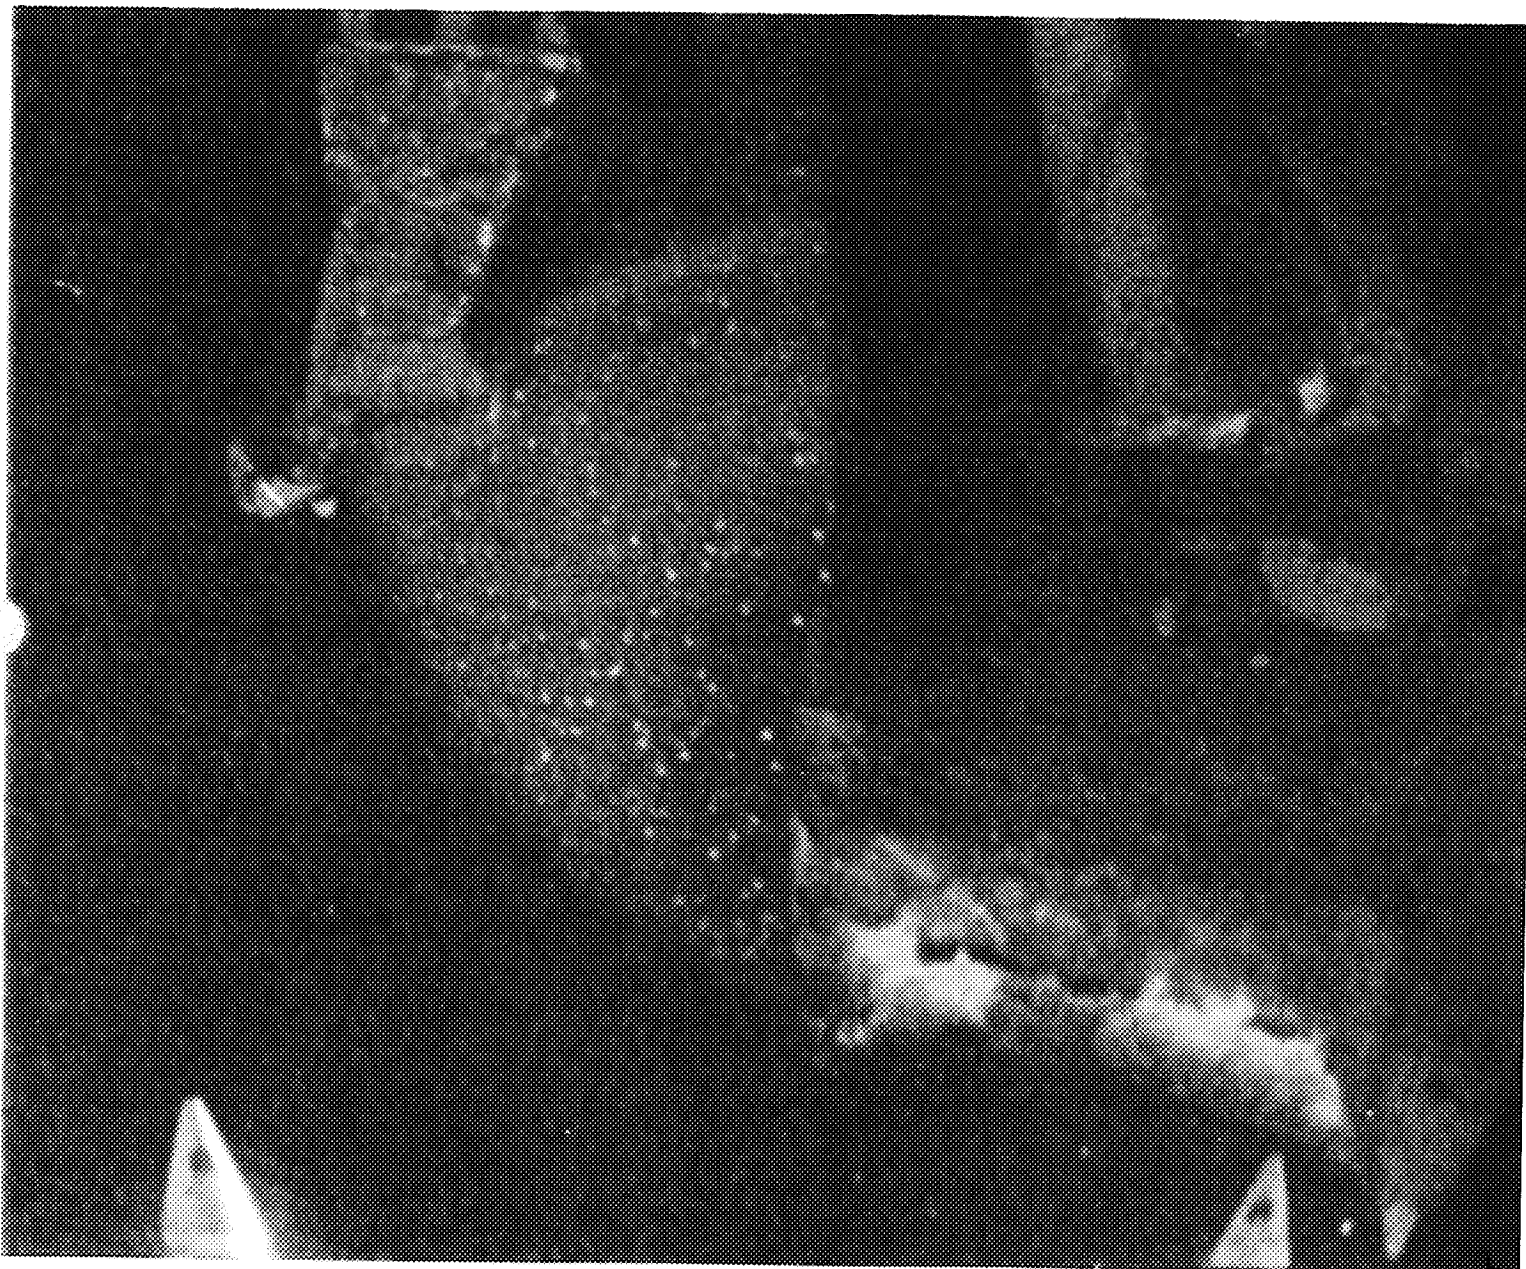
Photo 31: SRB Separation from External Tank

The wide angle ET/ORB LH2 umbilical camera provided a view of both SRB forward skirts/frustums/nose caps during separation. The nose caps, which are not recovered for post flight inspection, were intact and appeared to be in good condition.

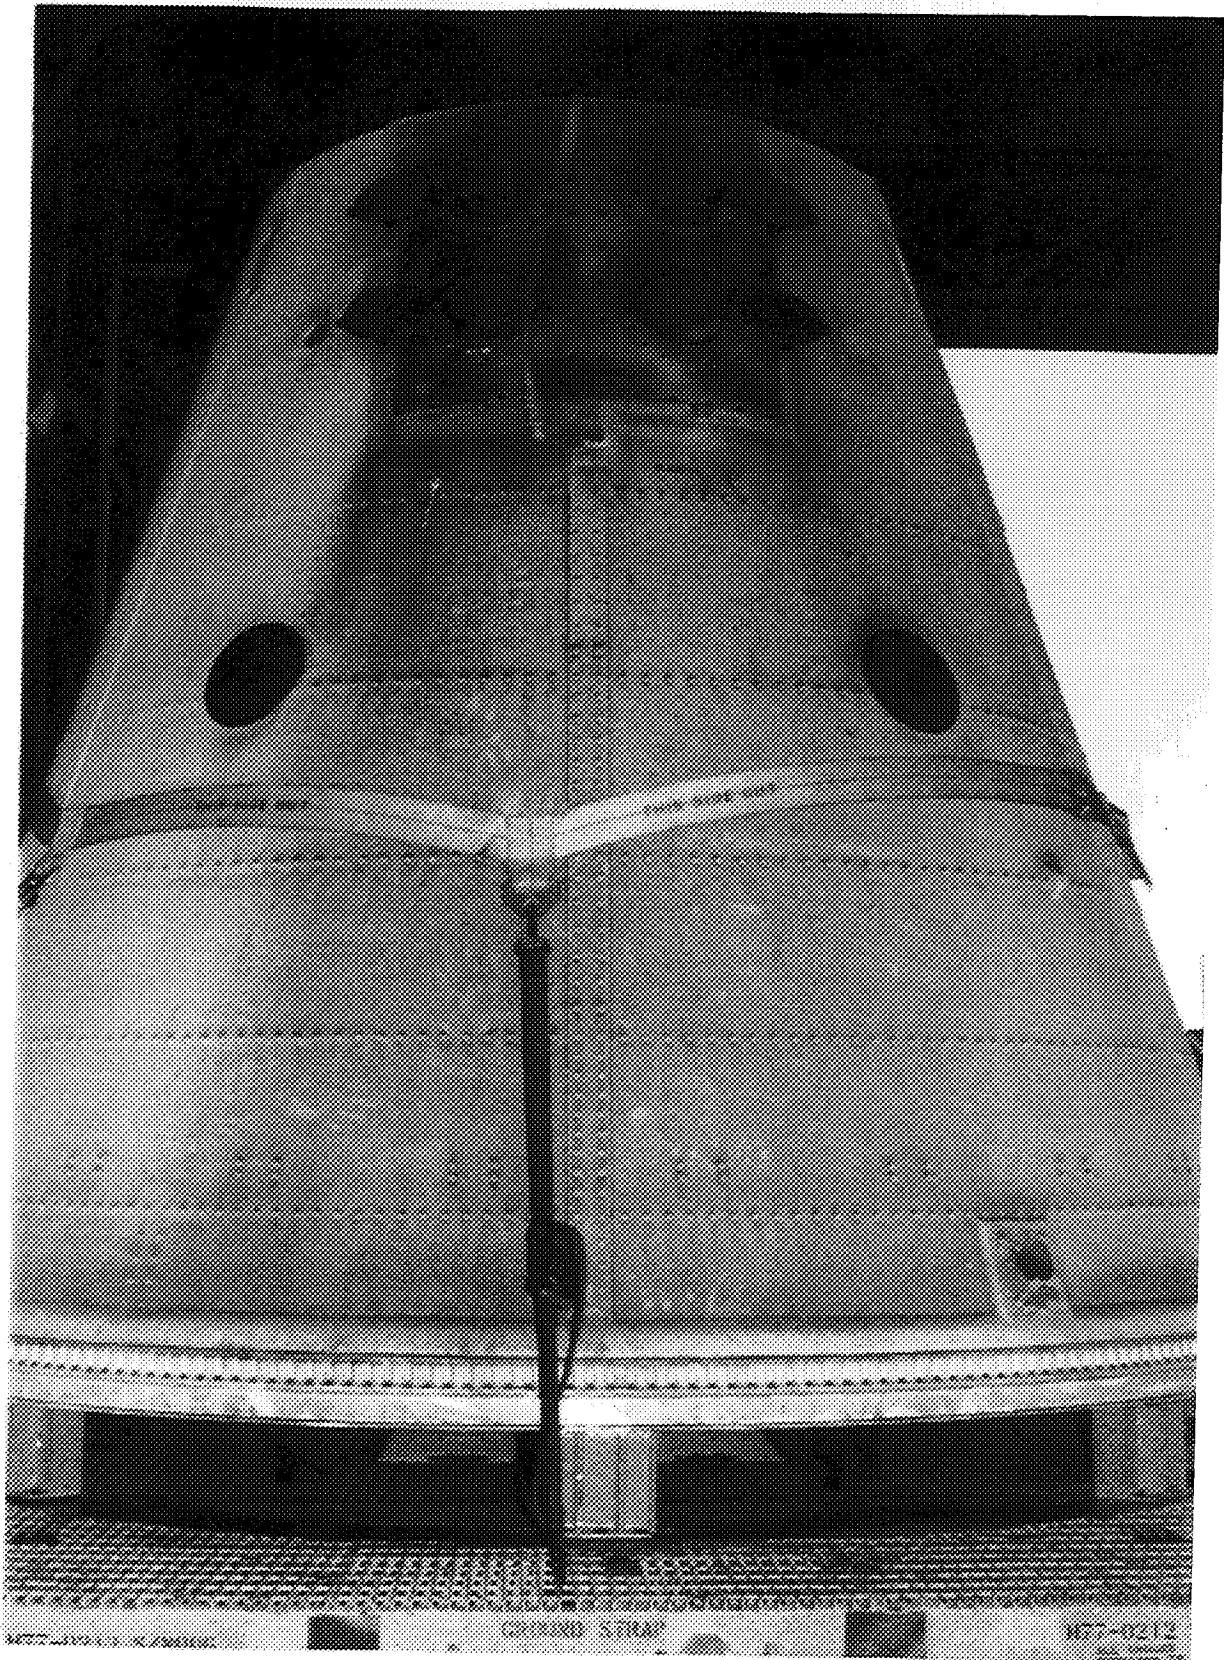
Photo 37: Frustum Post Flight Condition

Both frustums were in excellent condition. No TPS was missing and no debonds/unbonds were detected over fasteners or acreage. All eight BSM aero heat shield covers had locked in the fully opened position.
